NONPOINT SOURCE PROGRAM SUCCESS STORY

North Carolina

Partners Reduce Polluted Runoff from Agricultural Areas

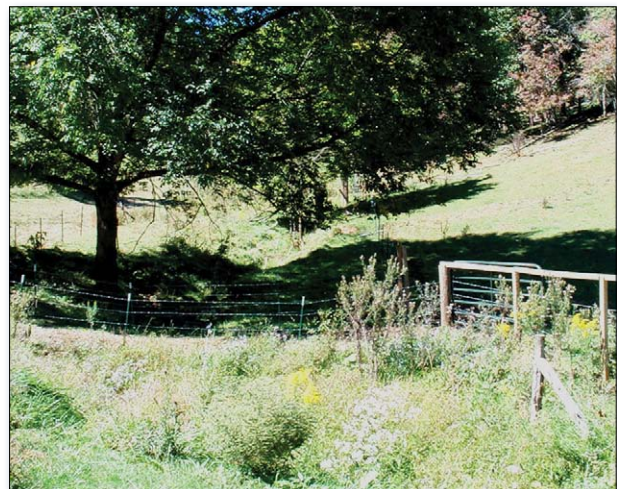
Figure 1. This fence prevents livestock from accessing Little Ivy Creek.

Partners installed more than 48,000 linear feet of livestock exclusion fencing to keep livestock out of the stream and reduce erosion (Figure 1). Project participants also installed 170 alternative watering facilities (Figure 2). One farmer adopted pasture and hay management plans, protecting an additional 530 acres of natural area. Additional BMPs funded by CWA section 319 grants helped develop a farm access road, 30 acres of riparian buffer and 25 feed/waste management structures (Table 1).

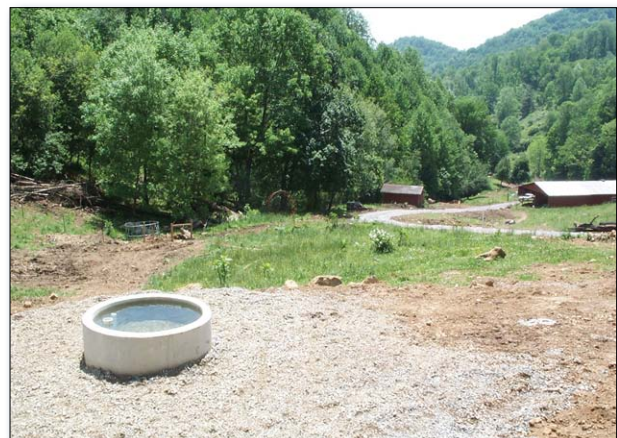
Figure 2. This alternative water source allows livestock to drink without entering Little Ivy Creek.
